TWA Flight 800

The Devil is in the Details

by Robert W Allardyce & Captain Howard Mann (TWA, retired)

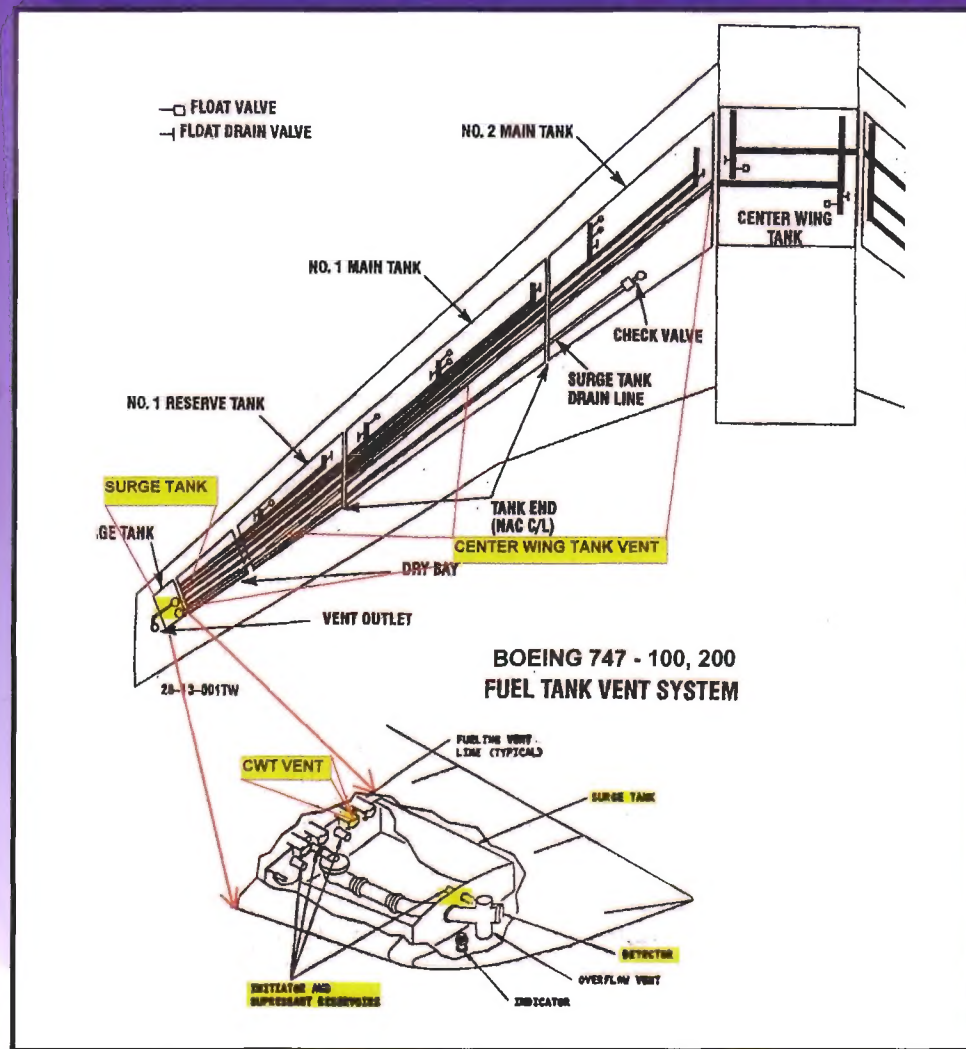
Of the Surge Tank Protection system (see above), TWA's 747-100 *Flight Handbook* offers the following description: "Each wingtip fuel tank is protected by a small fire extinguisher canister referred to as Surge Tank Protection or STP. Discharge of the canister is automatically controlled by a photoelectric [sensor]. Flight deck control is limited to system test of left and right wing canister[s]."

Highlighted in yellow, the photoelectric sensor was mounted on the outboard wall of each surge tank opposite the open end of the CWT's tank vent. Had a flame-front emerged from the CWT's tank vent, that photoelectric sensor was positioned to detect it and, within nanoseconds, flood the surge tank with inerting gas. Here is what the NTSB offered: "Although details of fire and soot documentation were performed by the Fire/Explosion Group, general observations of fire damage (or lack thereof) to the airplane systems were

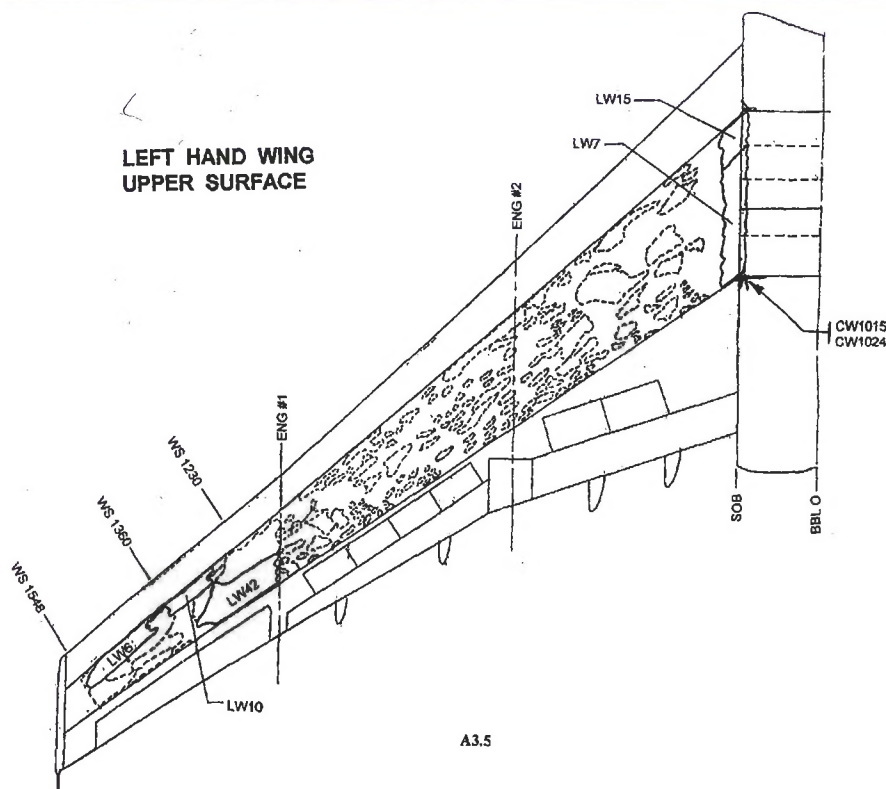
A3.5

LEFT HAND WING UPPER SURFACE

In reporting the condition of the wrecked left wingtip (above)—another loose end—the NTSB states: "The left wing outboard of about Wing Station (WS) 1230 [outboard of engine N° 1] broke into eight larger pieces and numerous smaller pieces. Layout of these pieces showed upward bending outboard of about WS 1230 (LW 8 & LW 42) and possible down bending outboard of WS 1360 (LW 5 & 6, LW 44). Both upper and lower wing skin panels between WS 1230 and WS 1380 showed upward curling at the inboard end (upper panel LW 42 and lower panel LW 8)." Between WS 1230 and WS 1360 is where the wingtip broke free.

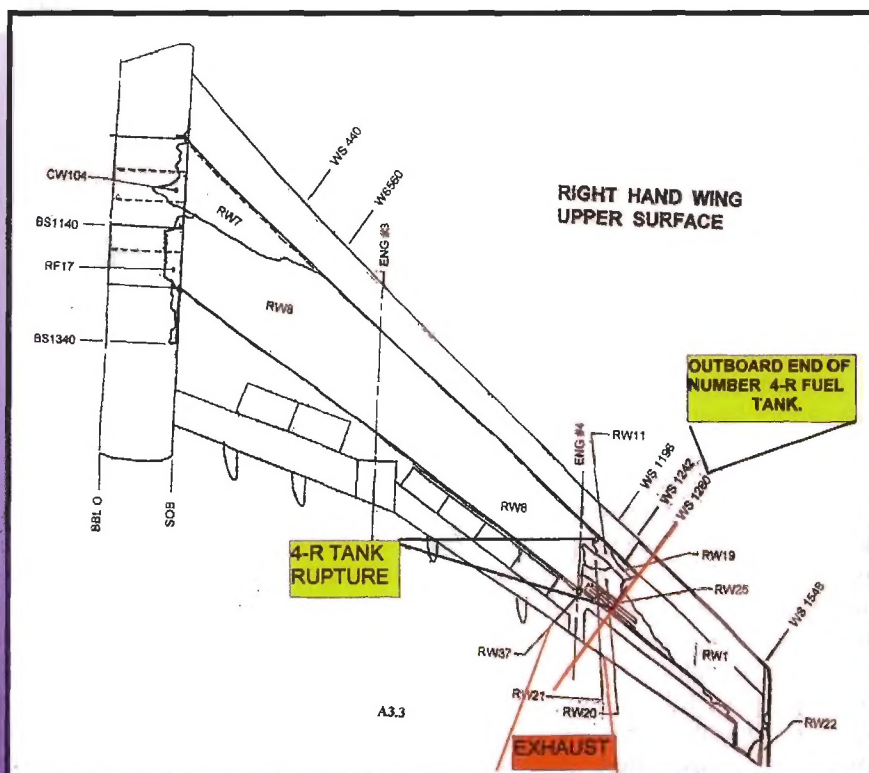
A3.3

Of the badly damaged right wingtip (right), the NTSB reports: "The outboard wing section measured approximately 29 feet [8.84m] and comprised the wing from approximately WS 1242 (at the front spar and leading edge) to the

wingtip. The wing structure between the inboard and outboard sections (WS 1224 to WS 1482) had broken into several pieces." In the next paragraph, the NTSB notes evidence of upward pressure on the right inboard wing where the breakage occurred. If the separations were not nearly simultaneous and one wingtip broke free first, the 747 would have rolled more severely than it did toward the loss

of lift. The remaining wingtip, then, would have been subjected to downward not upward pressure. Similarities between the diagrams show the way both upper skins splayed upward as they tore loose. This speaks of near-simultaneous upward pressure on both wingtips.

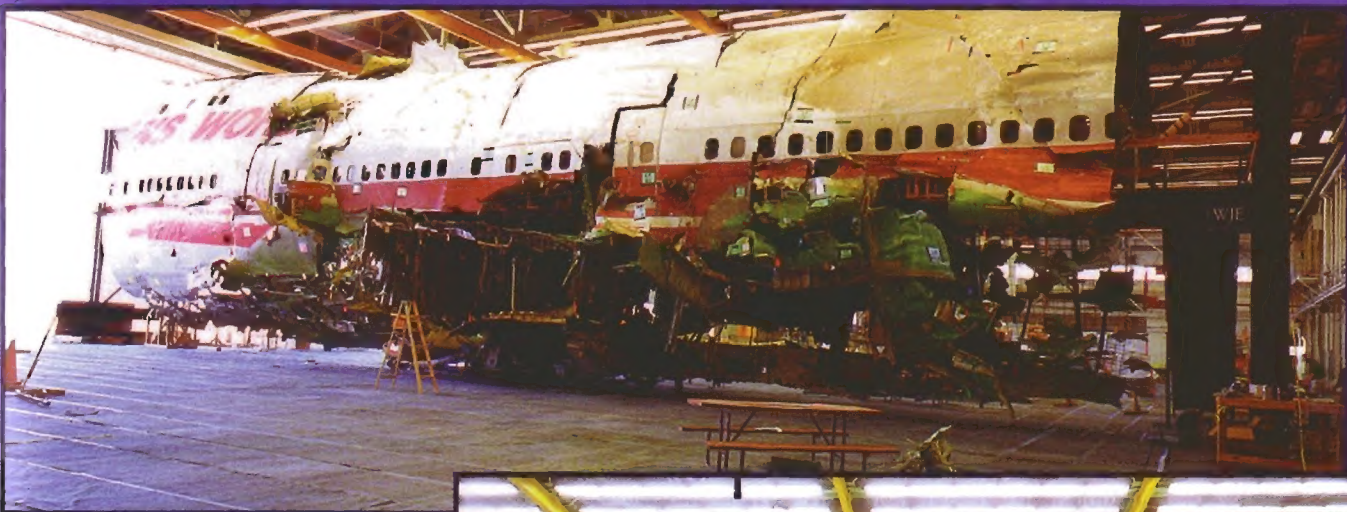
TWA 800 fuselage reconstruction. A photograph taken by the NTSB of the left side of the fuselage. The site of the breach was roughly abeam the L2 door.

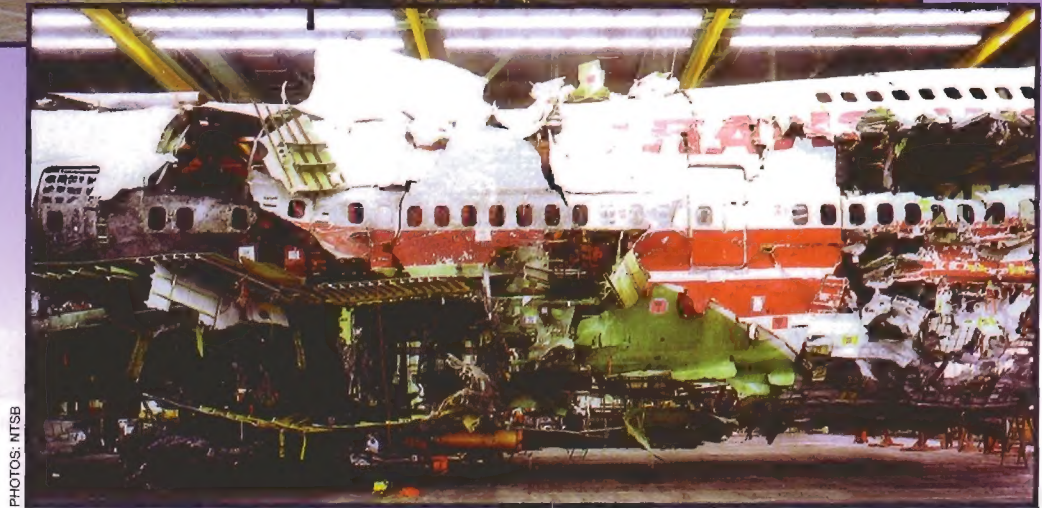
Original fuselage reconstruction. Another NTSB photograph shows that, unlike the left side, the skin of the right side of the forward section is splayed outward (that is from left to right). This is the result of a linear rather than an expanding omni-directional force emanating from the opposite side of the airframe.
